Cowichan Shoreline Stewardship Project (CSSP)

Annual Report

2015

March 2016

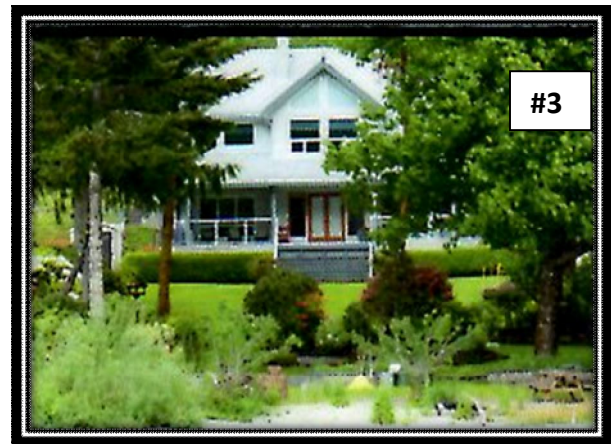
In 2014, and again in 2015, the majority of survey respondents selected a property showing a shoreline residence with a moderate amount of riparian tree and shrub clearing (50% of natural condition), and moderate beach clearings (Photo #3).

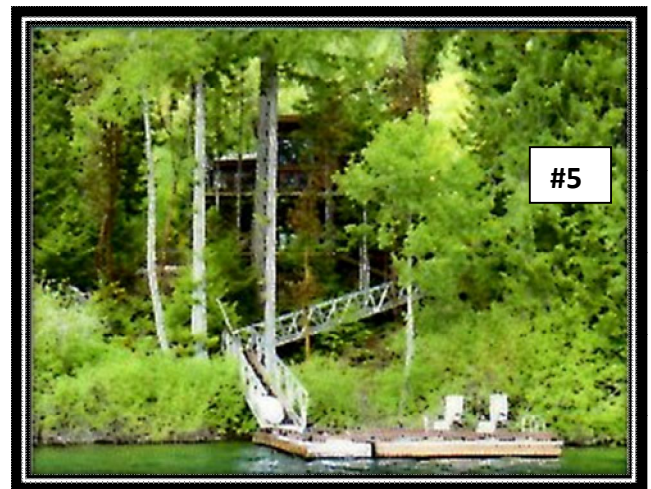
In both years, respondents preferred the highly vegetated residence with minimal disturbance to the shoreline and a small dock as having the best environmental features (Photo #5).

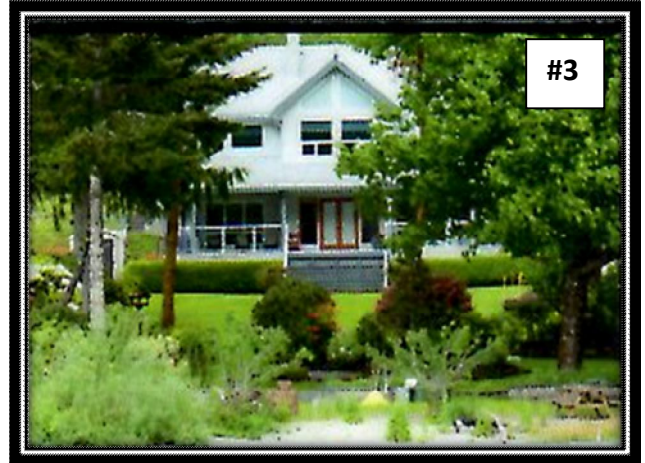
Respondents in both years overwhelming selected the property with modified shoreline features (i.e. lawn, beach clearing) with high re-sale \$\$ value (Photo #3).

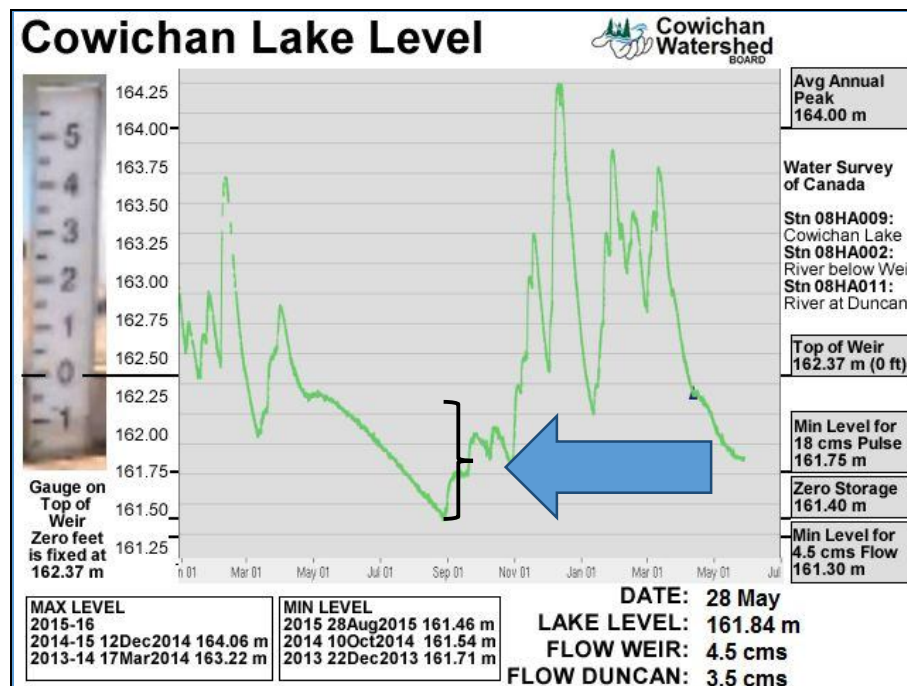
Figure 5. Cowichan Lake Water Levels in Summer of 2015.

In 2015, the Lake Cowichan area was again subject to very low spring/summer rainfall, which resulted in the lake level dropping rapidly (Figure 5). The drought resulted in a critically low lake level in late August of 161.46 m elevation. For the CSSP, the majority of lakeshore planting locations were at or below 162.5 m in elevation. In the fall/ winter, these sites will be flooded for six months of the year. The use of “wet” foreshore plants should ensure that plant survivals are optimized in the long term.

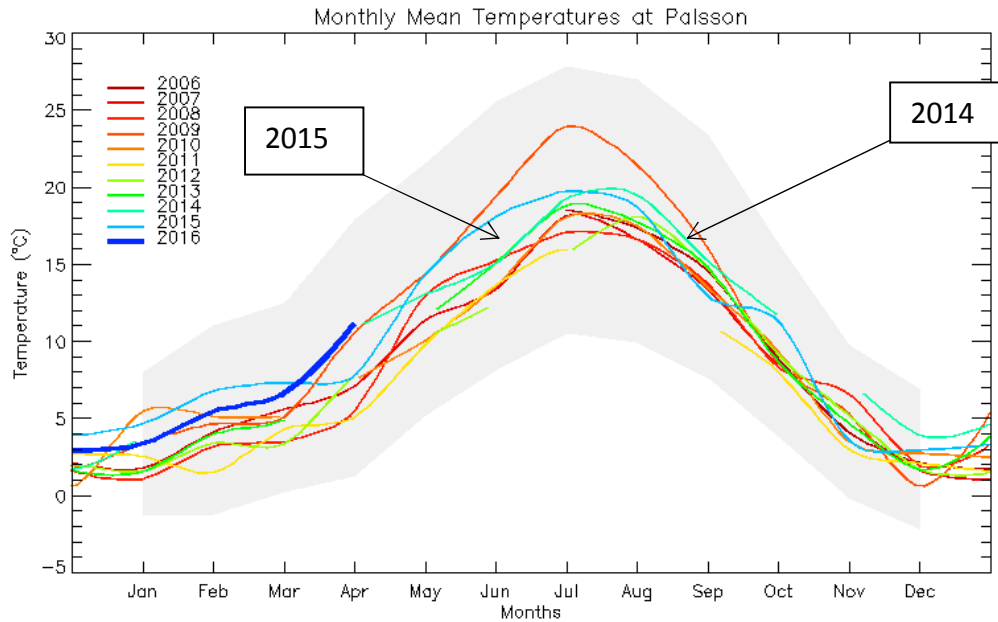
Figure 6. Monthly Average Ambient Temperatures Recorded at Palsson Elementary School in Lake Cowichan (2006 to 2016).

Warm average monthly temperatures were common in the summer of 2015 (Figure 6). There has only been one summer (2009) over the past 10 years that was warmer. The CSSP

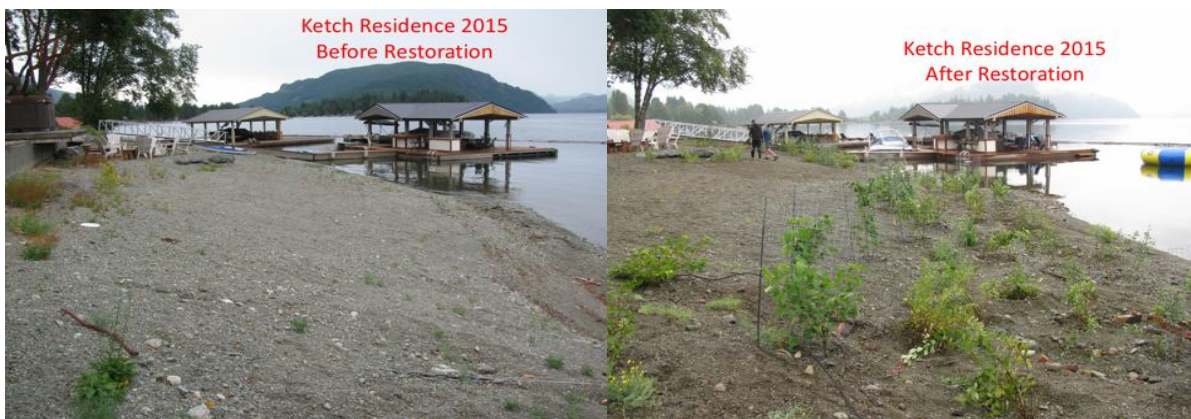
Figure 7. Site Conditions Subject to Flooding – (Before and After Planting).

Four of the nine sites restored in 2015 were lakeshore properties where gravel shorelines had an average of 10% vegetation coverage below the mean annual high water mark (Figure 7). Efforts to introduce foreshore plants capable of withstanding lake inundation should prove successful in stabilizing the shore and creating habitat for rearing salmonids (Law 2012).

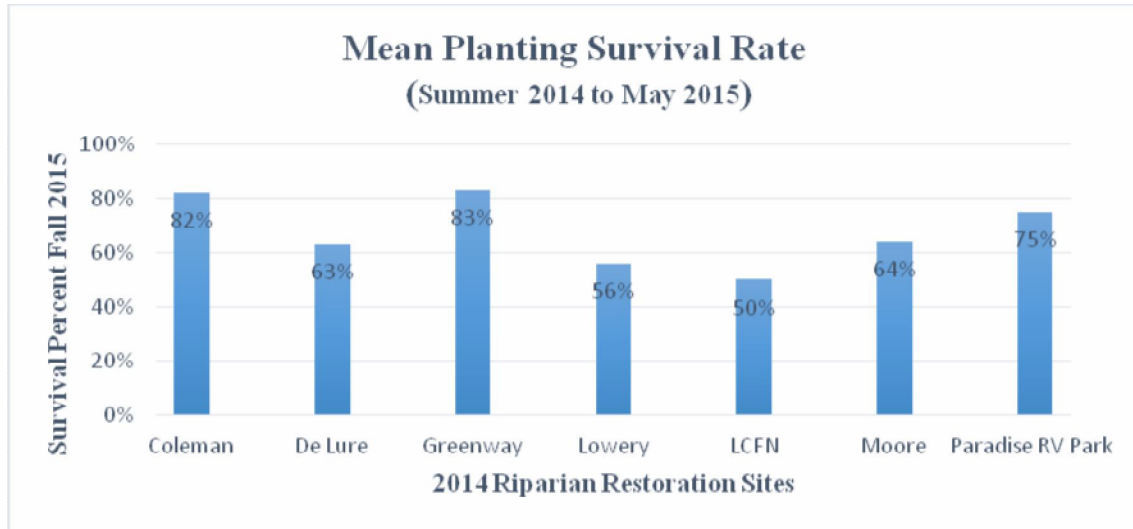
Figure 8. CSSP Riparian Plant Survival Rates for 2014 Sites.

Plant survival for sites completed in 2014 is 67 percent (Figure 8). Preliminary monitoring of the nine (2015) sites took place in October 2015. These results showed a survival rate average of 91 percent over a two to three month period (Figure 9). This higher survival rate during the critical first two months after planting suggests a better plant survival outcome in 2015 compared to 2014. This is likely due to the extensive use of soaker hoses and strategic herbivore fencing. A more quantitative comparison of survival rates between 2014 and 2015 will be conducted in the fall of 2016.

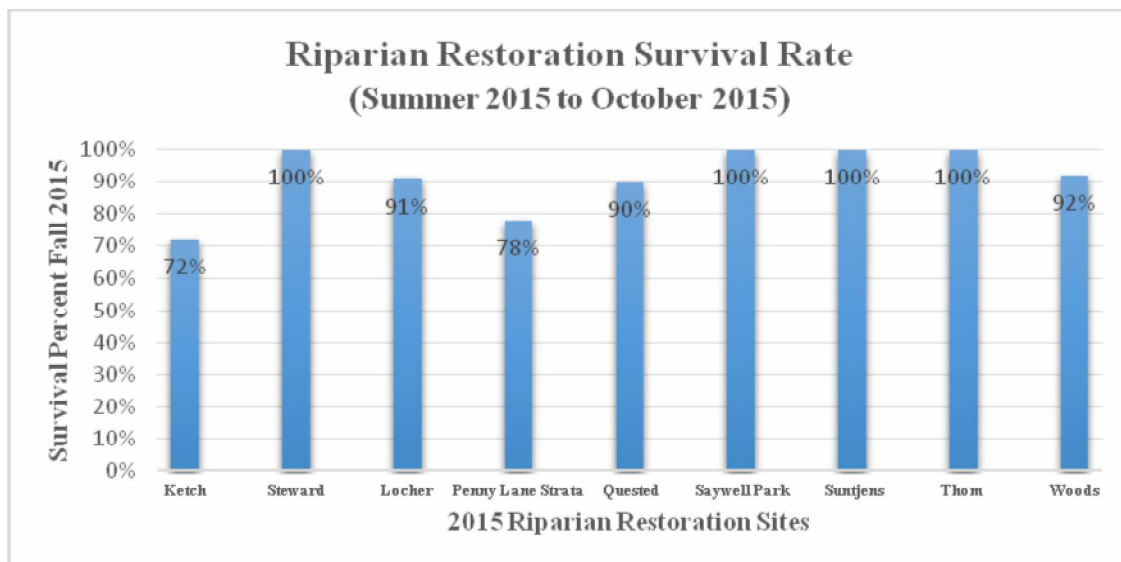
Figure 9. CSSP Riparian Plant Survival Rates for 2015 Sites.

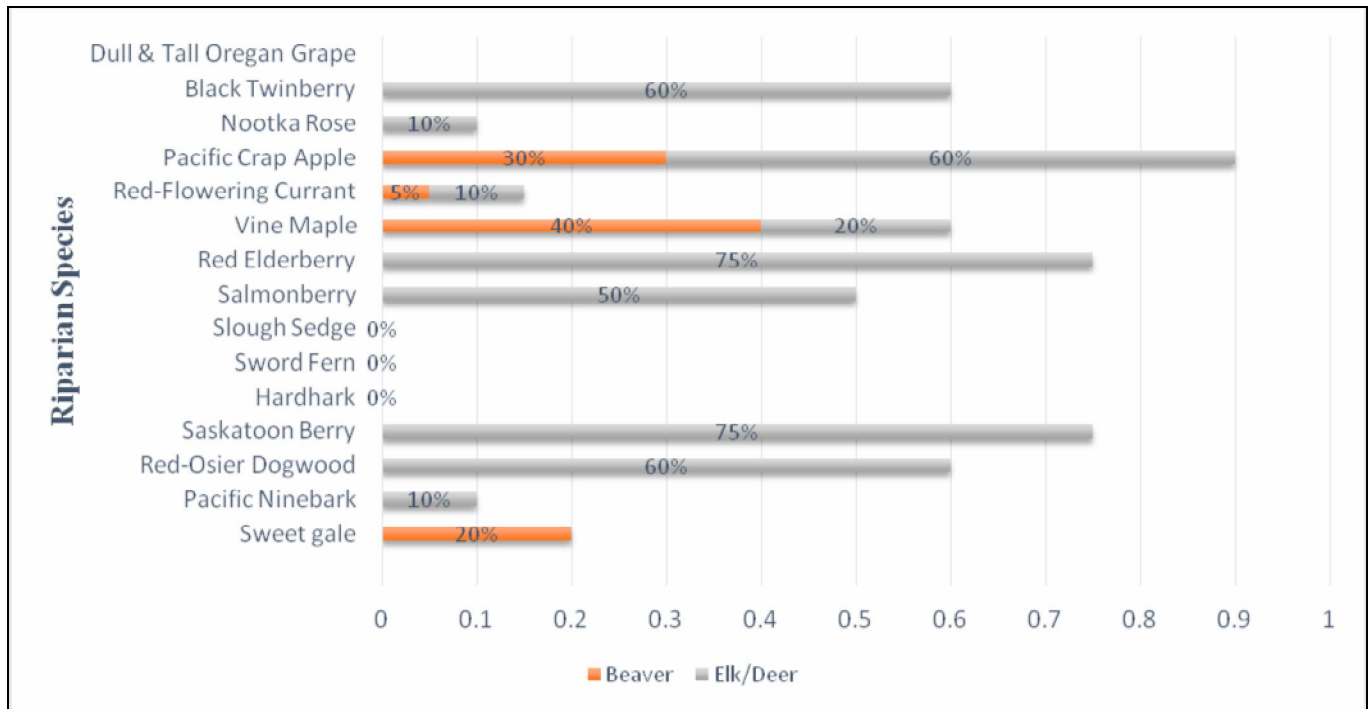
Figure 10. Percent of Plants Showing Browse and by What Herbivore Source.

Wildlife browsing of newly installed riparian plants indicate a preference for certain species over others by both ungulates and beavers. Browsed plants were counted by species and compared to planting totals (for 2014 and 2015) on site field forms. This generated an approximate percent of browse per riparian species/ungulates/beavers (Figure 9). Pacific Crabapple was the most preferred plant species by both ungulates and beavers. Red Elderberry and Saskatoon Berry were most preferred by ungulates, while beaver most prefer Vine Maple. Future use of these plants must include a robust fencing program to ensure plant survival.

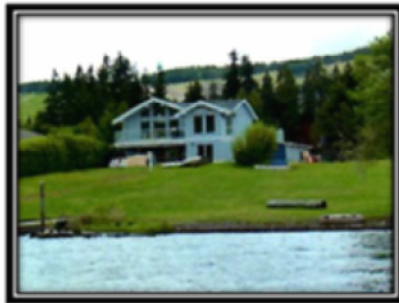
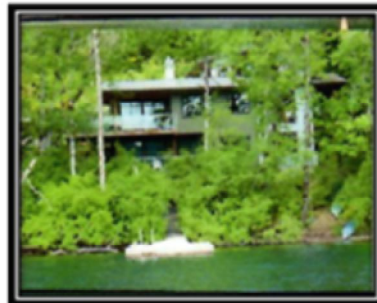
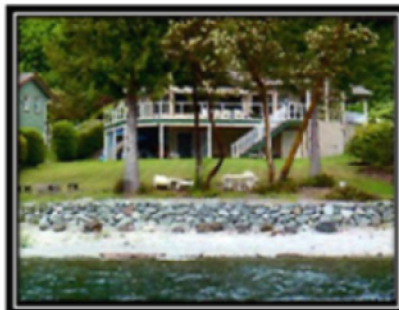
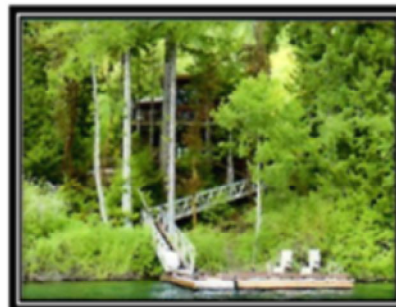
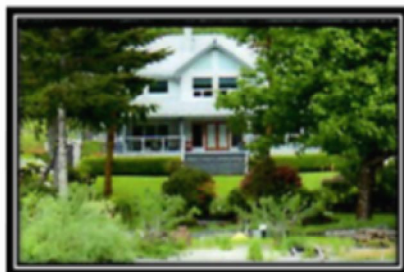
Pictures of Cowichan Lake Properties used for Opinion Survey.

For the attitude and preference questions, a series of five photos, representing different shoreline residences and “treatments” of vegetation along the shoreline were demonstrated. These photos were used in last year’s survey and show local properties that have modified their shoreline from a natural condition, such as:

- Removal of riparian trees and shrubs;
- Building erosion protection (rip-rap wall);
- Beach creation (through clearing or sand deposition); and
- Construction of docks.
