# **Cowichan Shoreline Stewardship Project 2018 Annual Report**

May 2019

## Summary

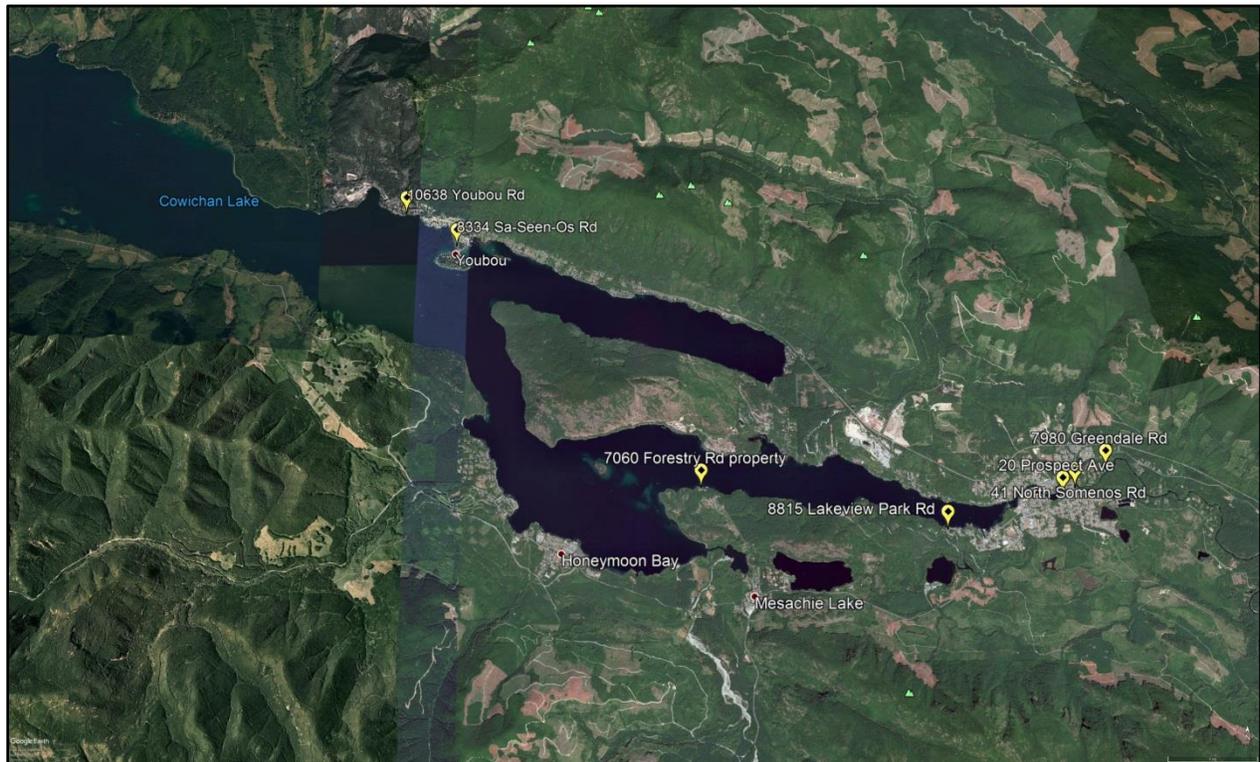
Figure 2. Location of the seven properties that underwent shoreline restoration by CSSP in 2018 (yellow symbols denote location of restored shoreline).

A total of seven sites were selected for riparian restoration in 2018, including five private residences, a Municipal Park, and one B.C. Ministry of Forests, Lands, Natural Resource Operations, and Rural Development (MFLNRORD) site (Figure 4).

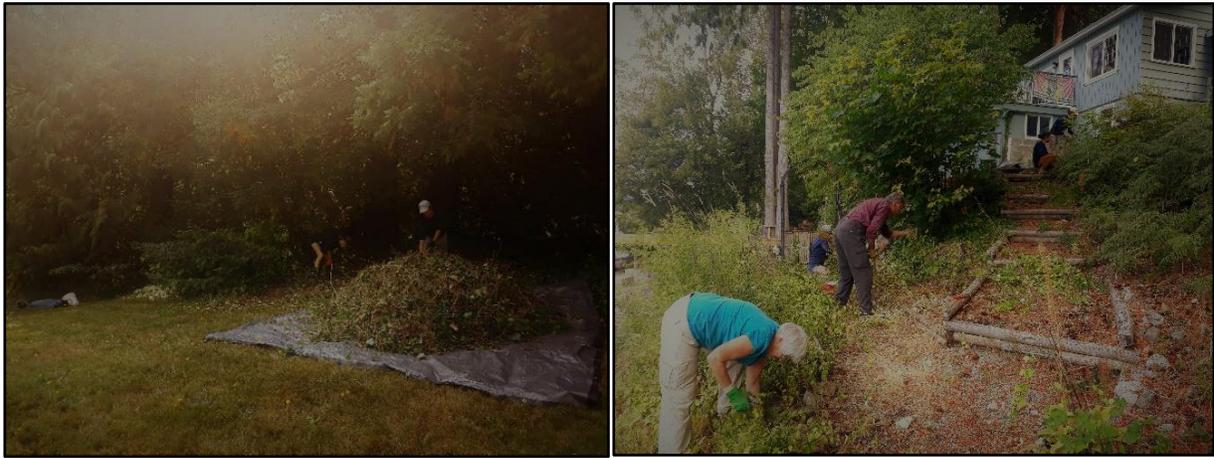
Figure 5. Invasive plant removal at a private residence on Cowichan Lake.

Invasive plants were removed from a total of 384 m<sup>2</sup> at three of seven properties. Approximately 95 person-hours were required for invasive plant removal prior to site restoration with native species, which was accomplished with assistance from CLRSS volunteers and a student planting crew (Figure 5, Table 1).

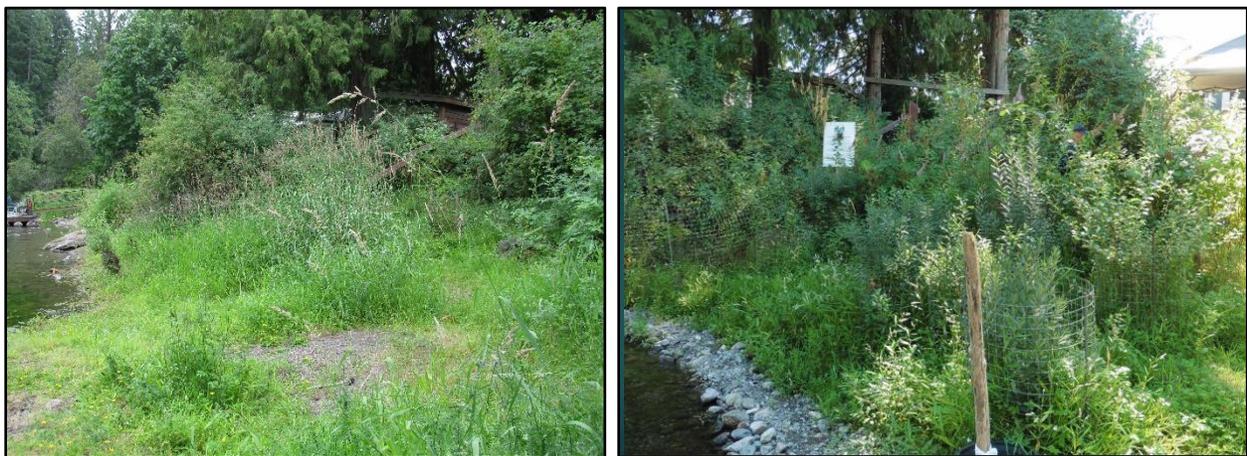
Figure 6. A site at a private residence restored in 2015, before (left) and after (right), in 2018

Figures 7-8 provide examples of photo-point monitoring conducted in 2018 of CSSP sites restored in 2015. The site in Figure 7 illustrates the progression of foreshore vegetation from 90% invasive Canary reed grass, to its status in 2018 with now dominant native riparian species which are contributing to shore stabilization and habitat creation. Figure 8 illustrates a foreshore site progressing from a cleared, manicured, gravel beach to a densely vegetated foreshore with increased riparian habitat value.

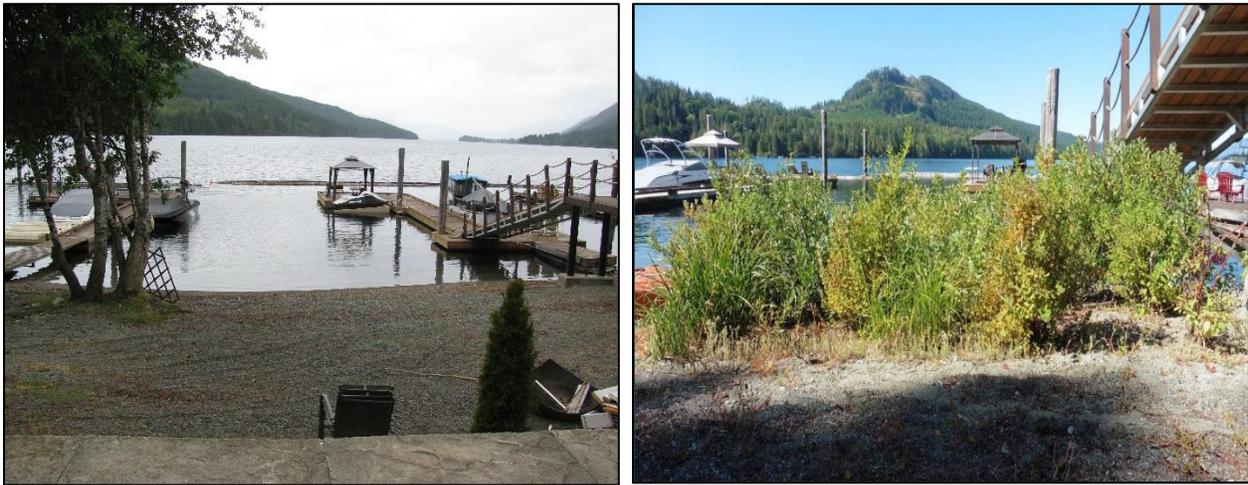
Figure 7. A site at a private residence restored in 2015, before (left) and after (right), in 2018

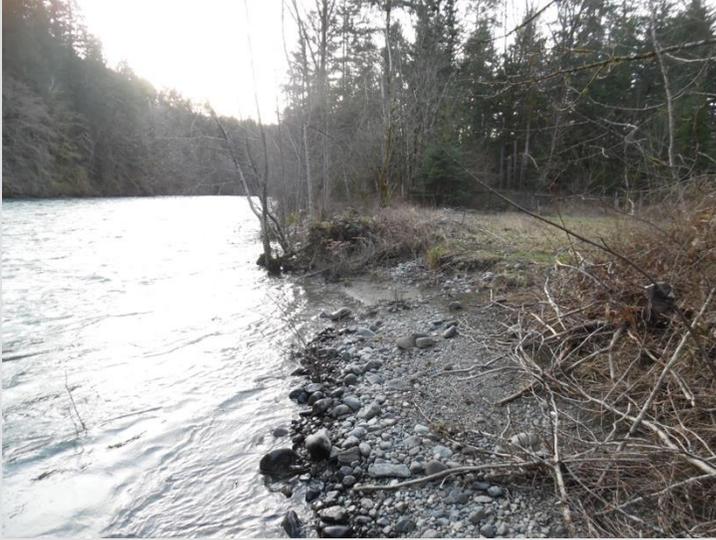
- Facing upstream
- Willow live-staking throughout eroded area

- Stabilize bank with willow root systems through live-staking
- Alders along high water's edge
- Black-cotton wood
- Conifers above high water
- Slough sedge along fringe of high water mark

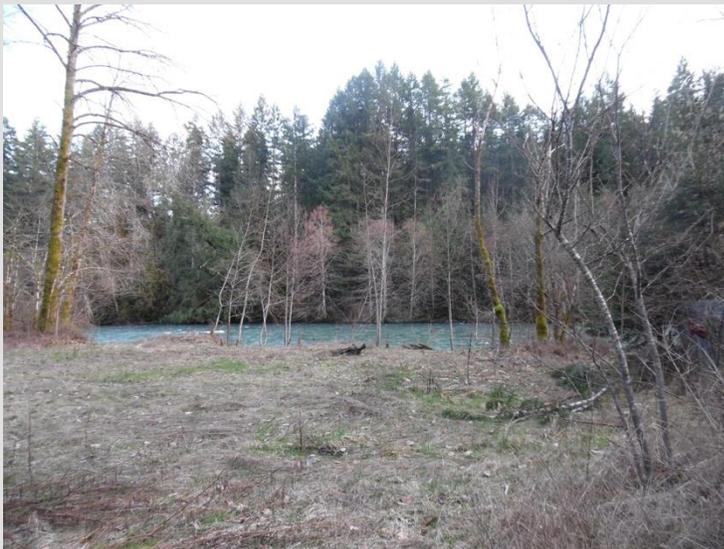
- Field upland planting polygon to be planted with diverse amount of upland riparian species suited for drier soils

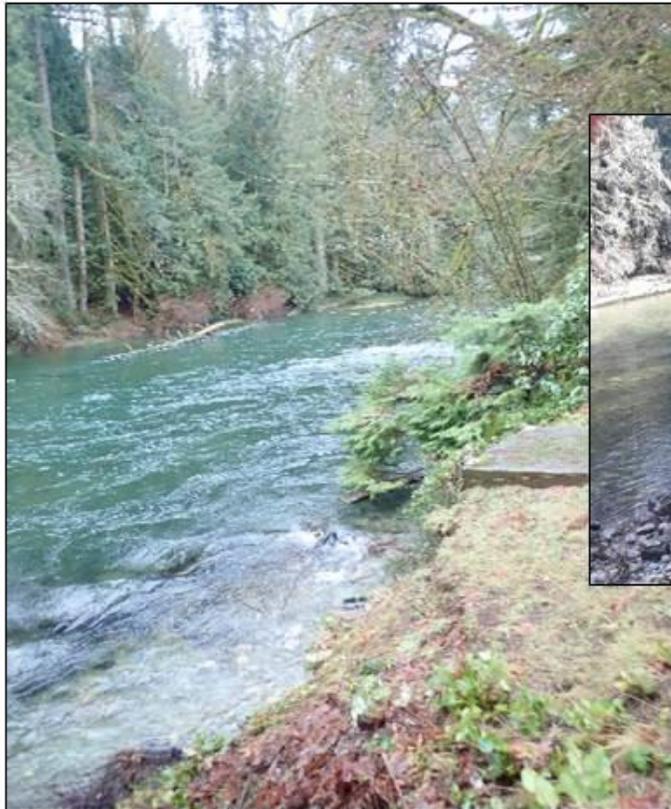
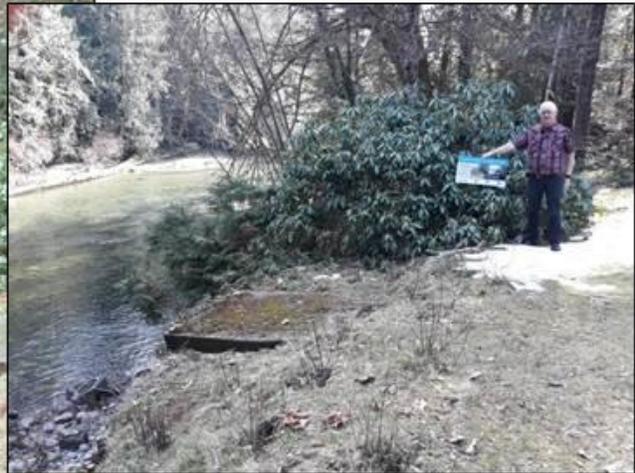
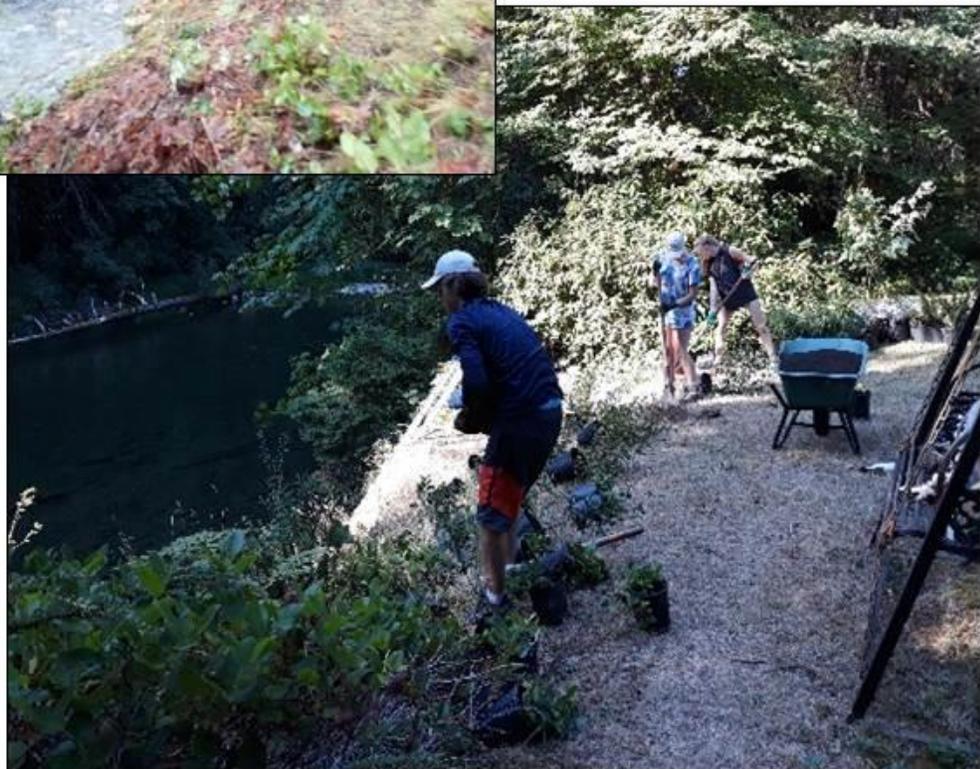
## 7980 Greendale Road, Lake Cowichan

Appendix 4: Before, during, and after photos of CSSP restoration sites in 2018.
