# Cowichan Shoreline Stewardship Project: 2016 Annual Report

Christine Brophy, CSSP Project Manager

British Columbia Conservation Foundation

November 2017

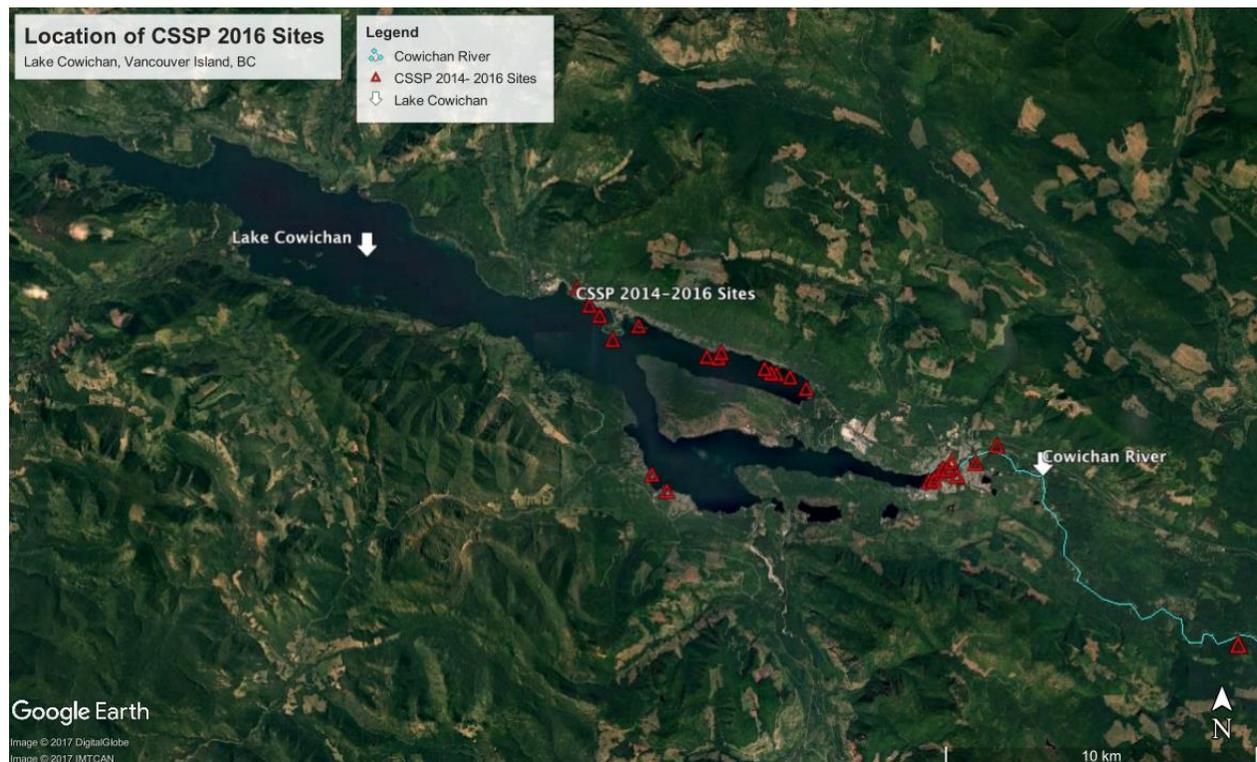
Figure 2: Location of CSSP 2014, 2015 and 2016 Sites on Cowichan Lake on Vancouver Island, BC.

CSSP riparian restoration sites are located along the north and south shores of Cowichan Lake within the Towns of Lake Cowichan, Youbou, and Honeymoon Bay and along the upper Cowichan River (Fig. 2). The majority of CSSP sites are on the north shore of Cowichan Lake, where the largest concentration of private properties are located.

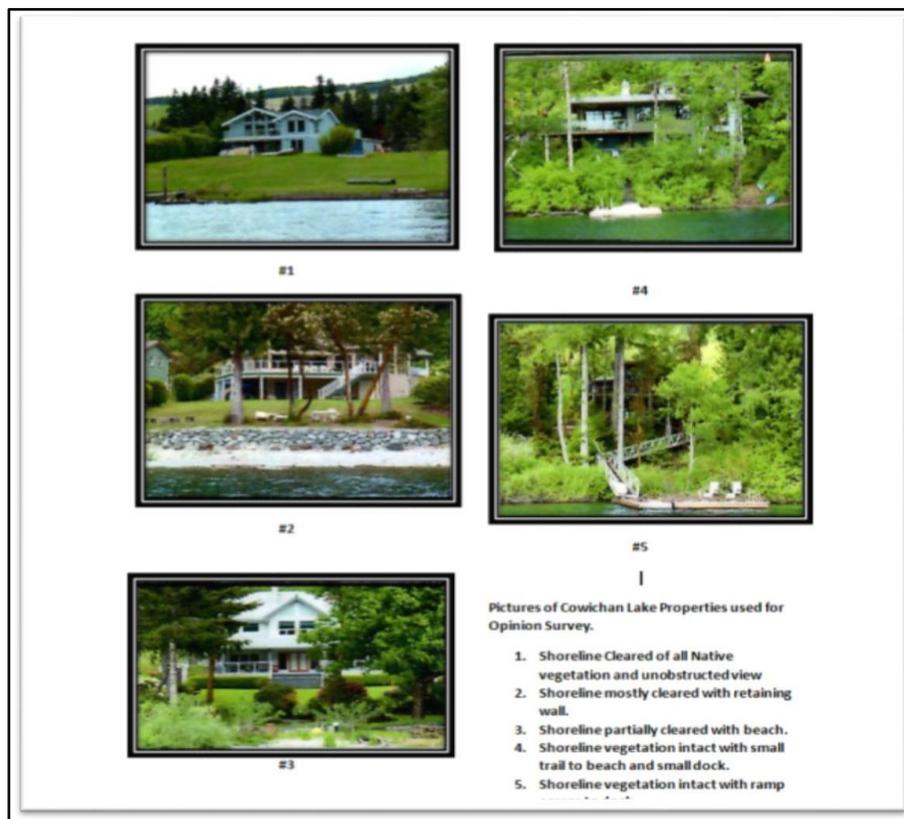
Figure 3. Five photos showing typical riparian situations in the Cowichan Lake study area.

For the attitude and preference questions, a series of 5 photographs (Fig. 3), representing a variety of shoreline residences and “treatments” of vegetation along the shoreline were shown to landowners (Appendix 2). The photos used in the 2016 survey represent five typical riparian conditions that exist in the Cowichan study area.

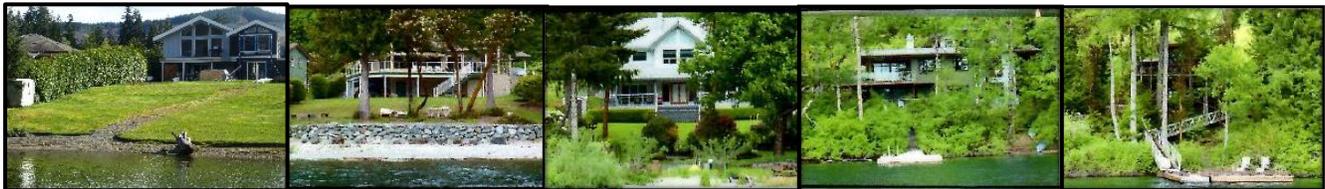
Table 2. CSSP Riparian Area Opinion Survey results: Preference for shoreline properties based on social considerations.

Social considerations	2014 (88 Participants)	2015 (82 Participants)	2016 (53 Participants)
Which property has the best view?	<b>35.6% Photo #3</b>	<b>35.4% Photo #3 &amp; #4</b>	<b>39.6% Photo #4</b>
Which property would you prefer for privacy?	<b>38.6% Photo #5</b>	<b>44.6% Photo #5</b>	<b>39.6% Photo #5</b>
Which property has the most recreation value?	<b>42% Photo #3</b>	<b>47.5% Photo #3</b>	<b>30.2% Photo #3</b>

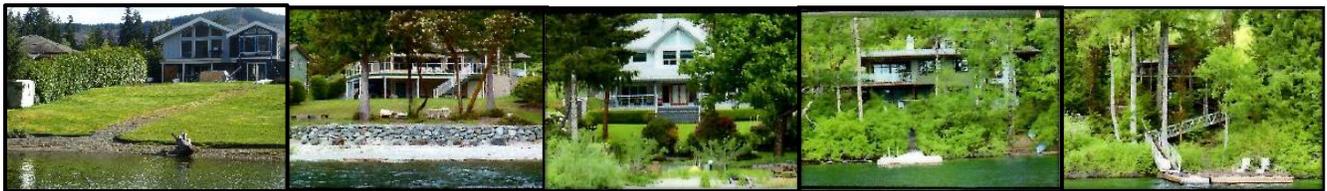
Table 3. CSSP Riparian Area Opinion Survey results: Preference for shoreline properties based on environmental considerations.

2014	2015	2016
<b>Environmental conditions</b>	<b>(88 Participants)</b>	<b>(82 Participants)</b>	<b>(53 Participants)</b>
Which property would be best at resisting erosion and protecting water quality?	58% Photo #5	51.9% Photo #5	56.6% Photo #5
Which property provides the best habitat for fish and wildlife?	55.1% Photo #5	76.3% Photo #5	69.8% Photo #5

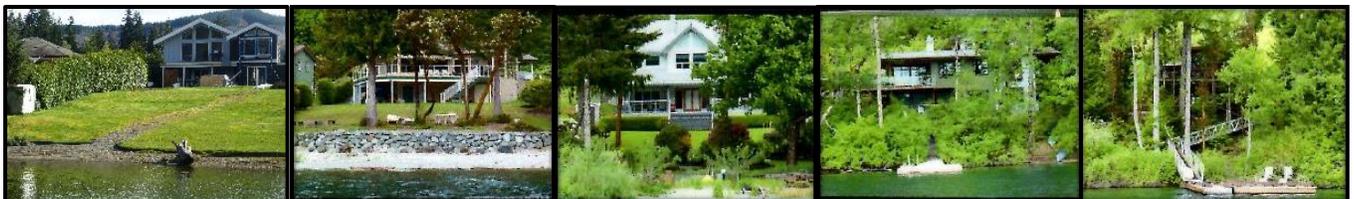
Table 4. CSSP Riparian Area Opinion Survey results: Preference for shoreline properties based on economic considerations.

2014	2015	2016
<b>Economic Considerations</b>	<b>(88 Participants)</b>	<b>(82 Participants)</b>	<b>(53 Participants)</b>
Which property would require the least maintenance effort and cost?	42.2% Photo #5	48.8% Photo #5	52.8% Photo #5
Which property has the greatest resale value?	58.3% Photo #3	58.5% Photo #3	49.1% Photo #3

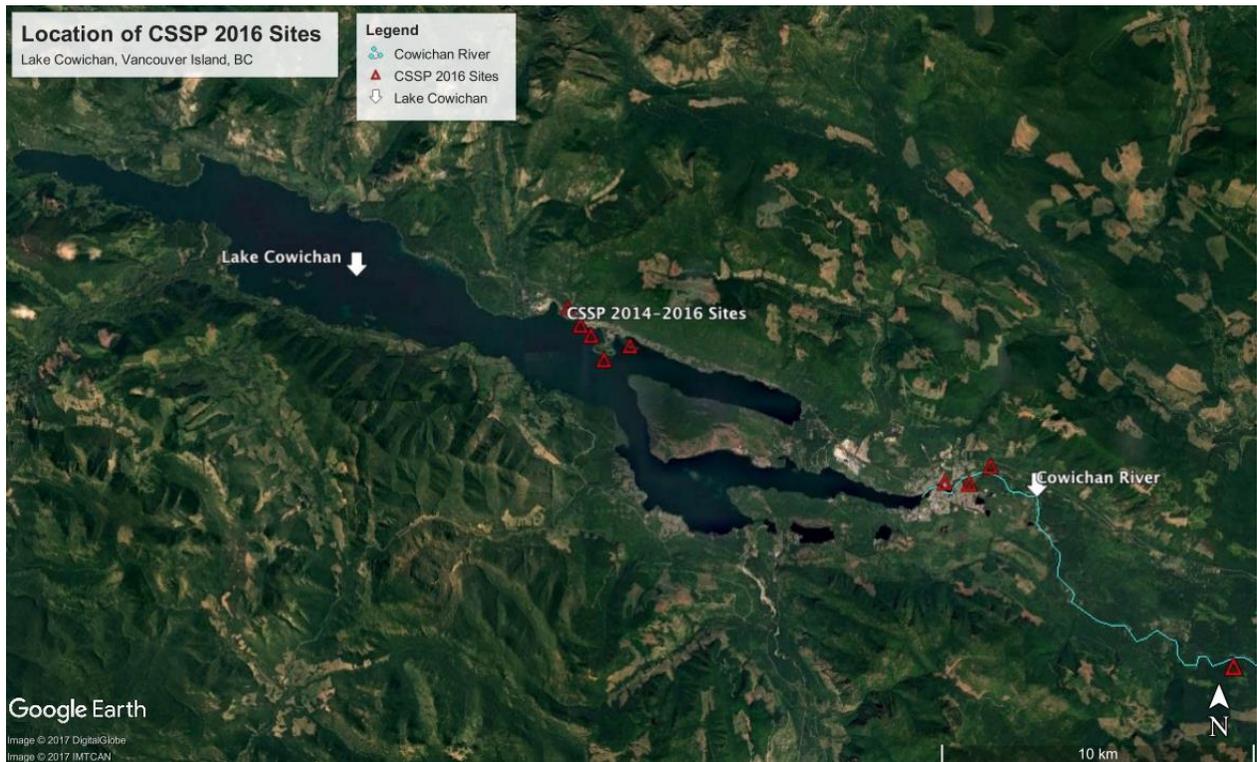
Figure 4. Location Map of CSSP 2016 properties where riparian restoration was completed on Cowichan Lake and River (red triangles).

In the Spring of 2016, a total of 8 properties were selected and confirmed for riparian restoration activities. The properties consisted of six private summer homes on the South shore of Cowichan Lake, one residential home located downstream on Cowichan River, and one Town of Lake Cowichan municipal lot located at the outlet of Cowichan Lake (Fig. 4).

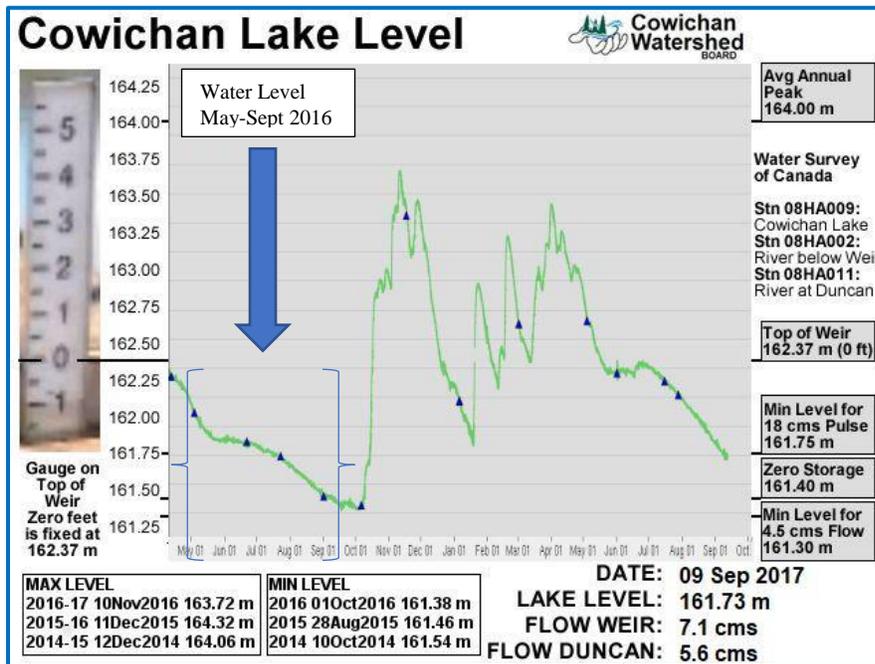
Figure 5. Cowichan Lake water levels during CSSP planting May to September 2016 (Cowichan Watershed Board, 2016)

Drought tolerant upland riparian species such as Nootka rose (*Rosa nutkana*) and Oceanspray (*Holodiscus discolor*) were planted 1-3m above the 164m mean annual high-water line, and in areas of foreshore with steeper slopes where water runoff is greatest. From May to September 2016, Cowichan Lake levels steadily declined (Fig. 5), and average air temperature was 26.7° Celsius (Fig. 6) for July and August (Government of Canada 2017). This introduced local weather stressors on the new riparian plants.

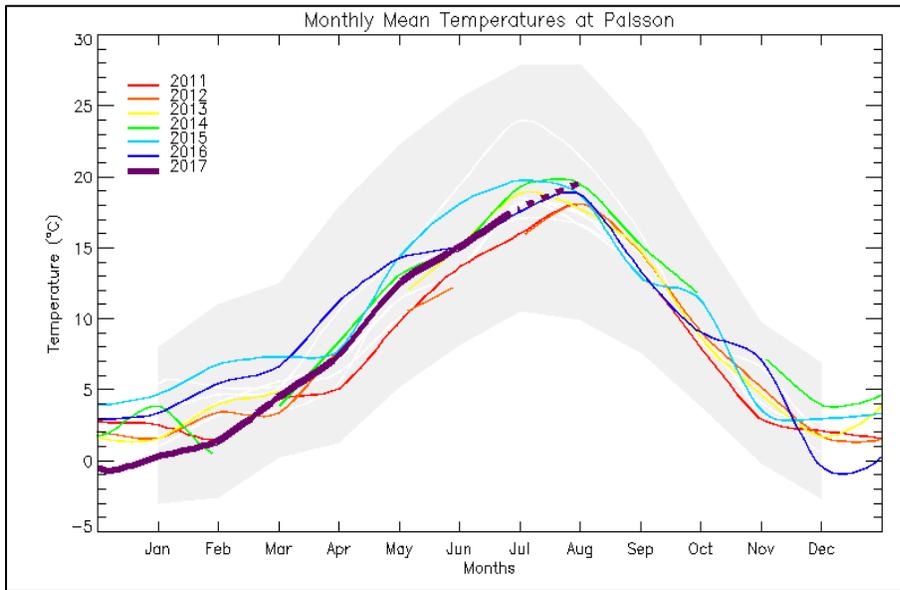
Figure 6. Monthly average air temperatures recorded at Palsson Elementary School in Lake Cowichan (2011-2017; Government of Canada 2017).

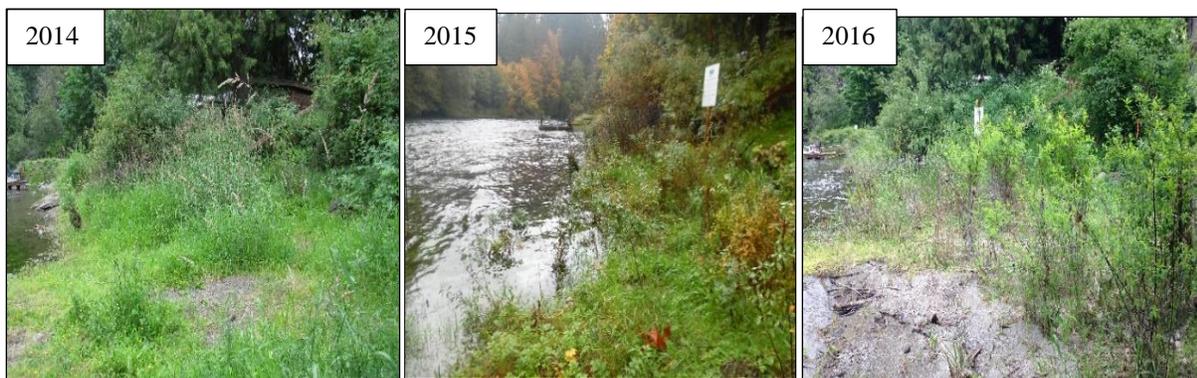
Figure 7. Selected riparian restoration site showing the progression from invasive species to native riparian vegetation in 2014, 2015 and 2016.

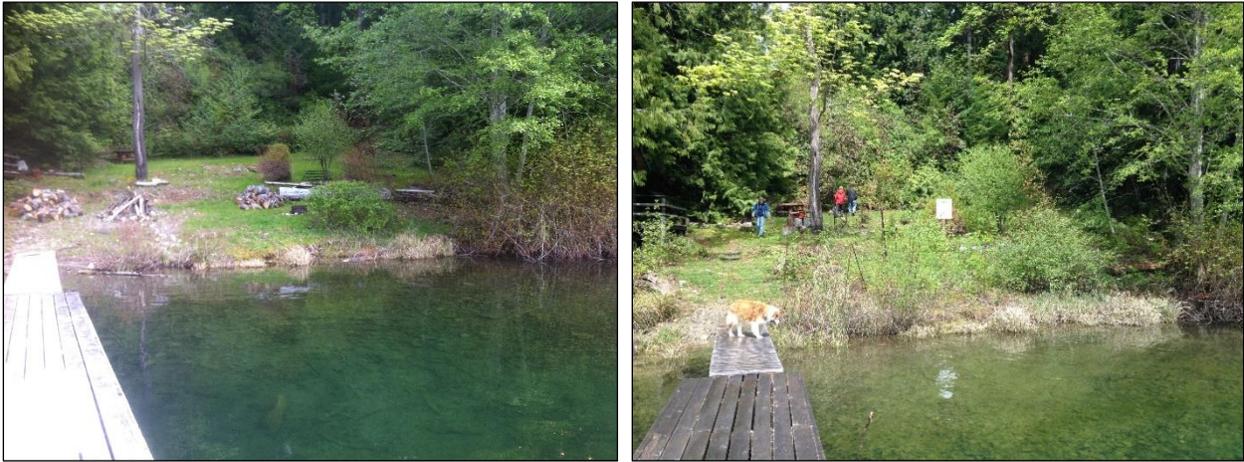
Figure 8. Before (2014) and after (2017) Riparian Restoration Site photos.

Figure 8 shows a riparian restoration site in 2014 and again in 2017. From May to July 2017, plant survival monitoring was conducted at all 2014, 2015 and 2016 sites (grand total of 24 sites). Monitoring results for just the 2016 sites showed that riparian plant survival was 88% (Fig. 9). Including results from the 2014 and 2015 sites showed an increasing trend in plant survival from 2014 to 2016 (Fig. 10). This survival increase is likely due to incorporating mandatory fencing and watering systems into riparian restoration plans starting in 2015.

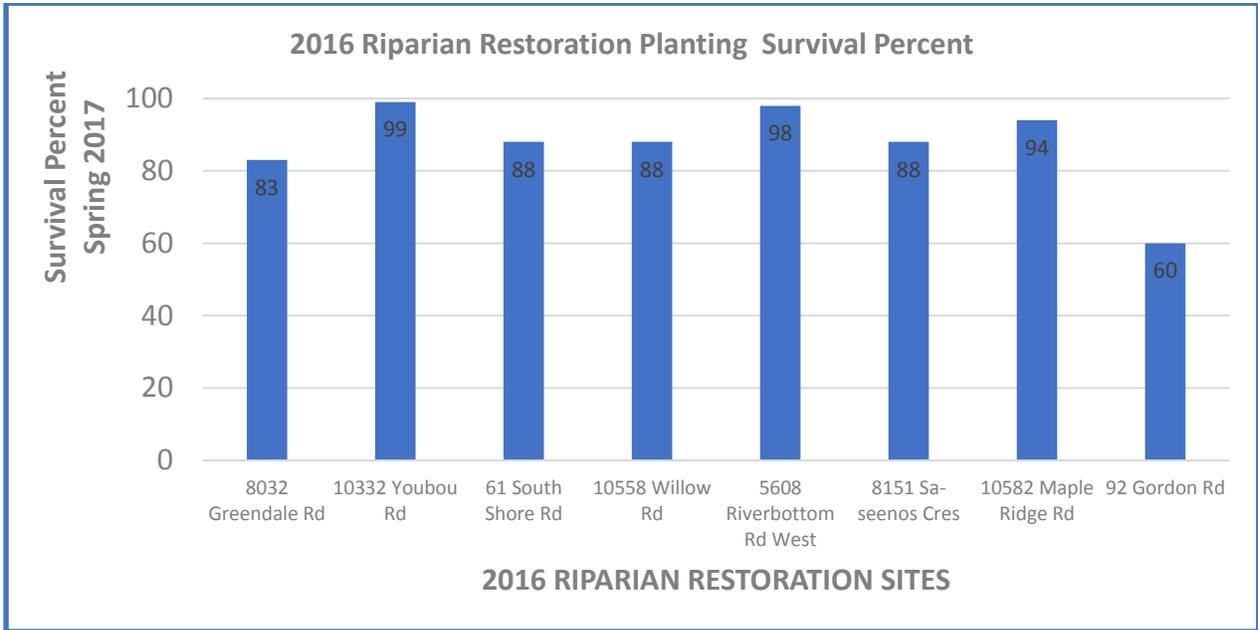
Figure 9. Riparian plant survival monitoring results for 2016 Riparian Restoration Sites (monitored in May – July 2017).

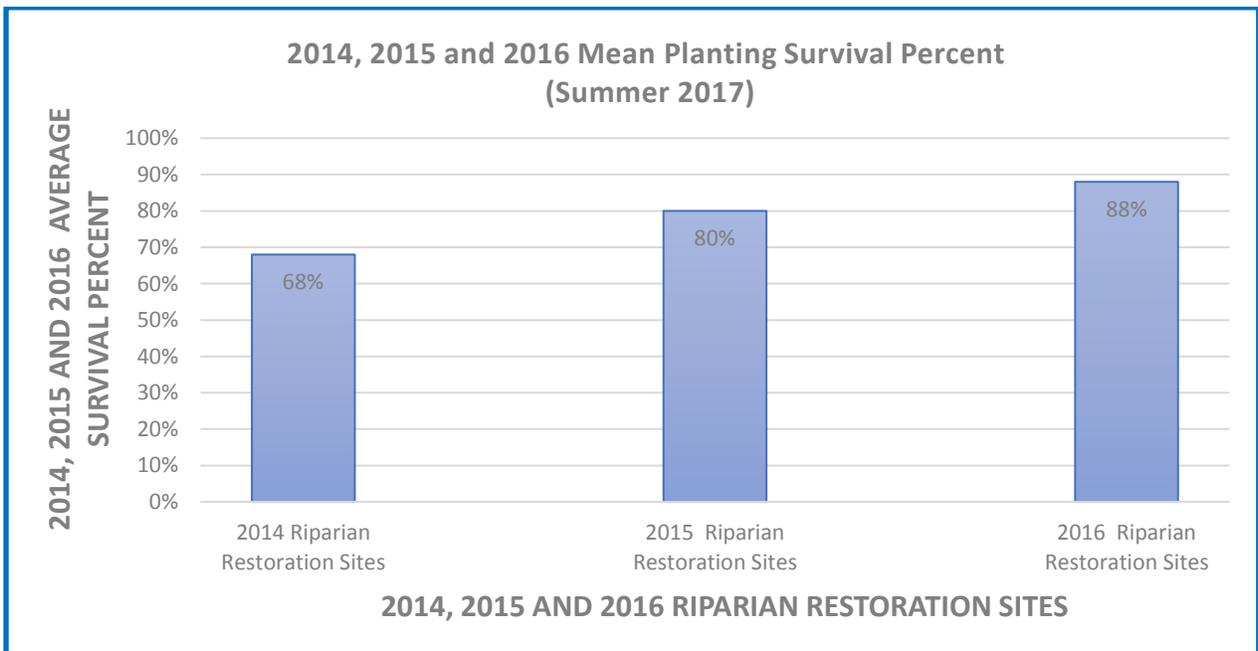
Figure 10. Riparian plant survival monitoring results for 2014, 2015 and 2016 Riparian Restoration Sites.

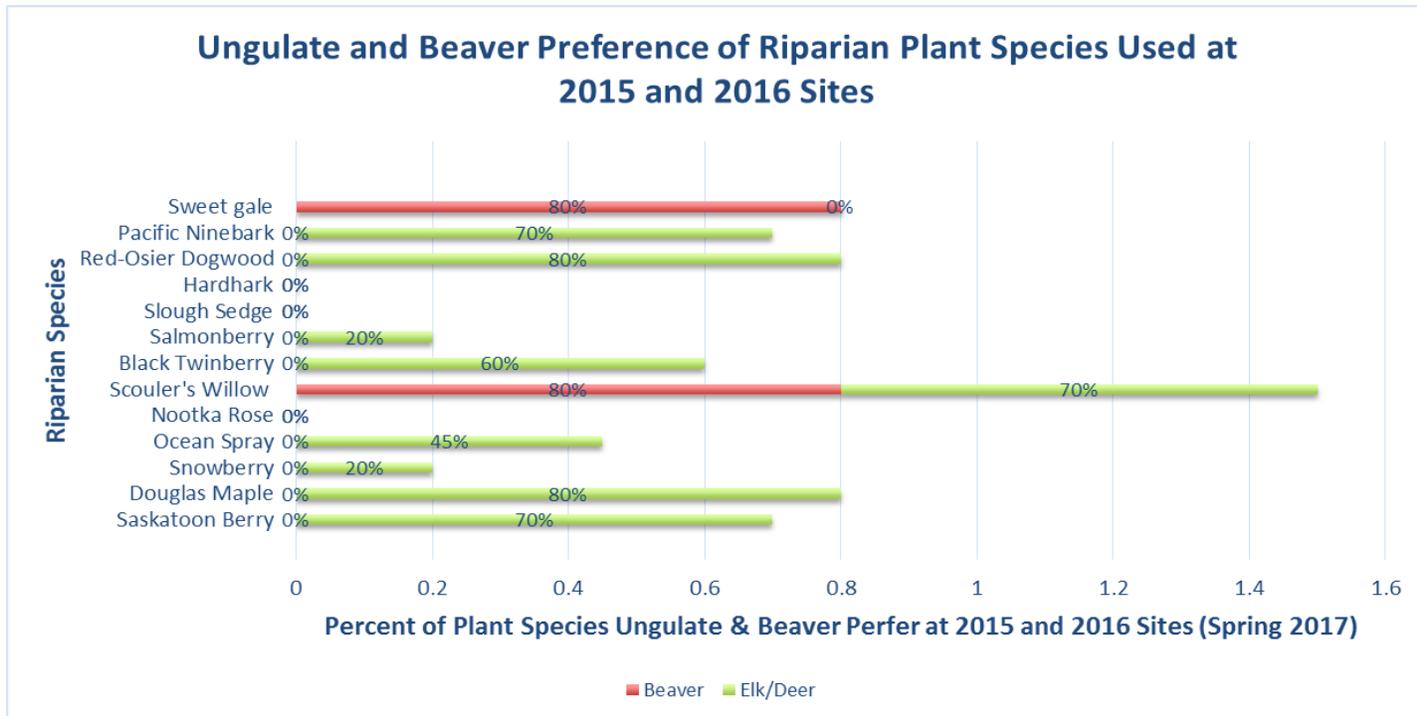
Figure 11. Herbivore browse preference for riparian plant species from 2014, 2015 and 2016 Riparian Restoration Sites.

Wildlife browsing on newly installed riparian plants indicate a preference for certain species by ungulates and beavers (Fig. 11). Browsed plants (both in cages and not) were counted by species and compared to planting totals for 2014, 2015 and 2016. This generated an approximate percentage of browse per riparian species by ungulates and beavers. Compared to the 2015 browse preference results, where Pacific Crabapple was the most preferred plant species by both ungulates and beavers, Scouler’s willow was the most preferred species by all herbivores in 2016. Deer and elk most preferred Red osier dogwood and Douglas maple in 2016, while beavers preferred Sweet gale and Scouler’s willow. These observations were recorded in the spring of 2017.

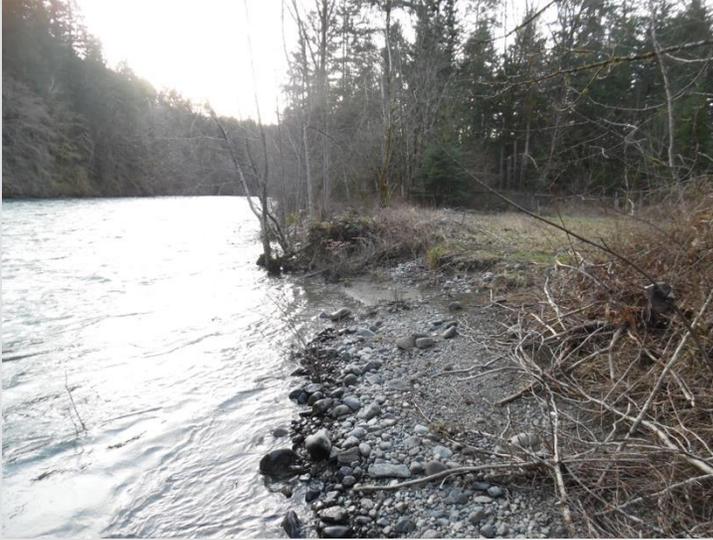
- Facing upstream
- Willow live-staking throughout eroded area

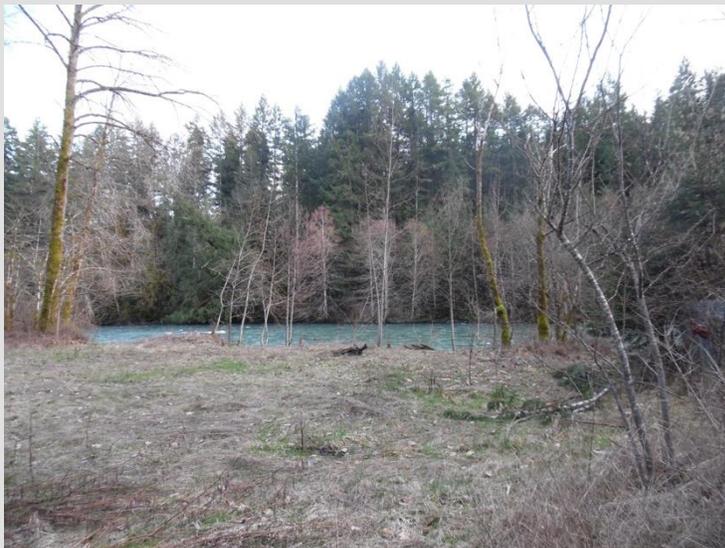
- Field upland planting polygon to be planted with diverse amount of upland riparian species suited for drier soils

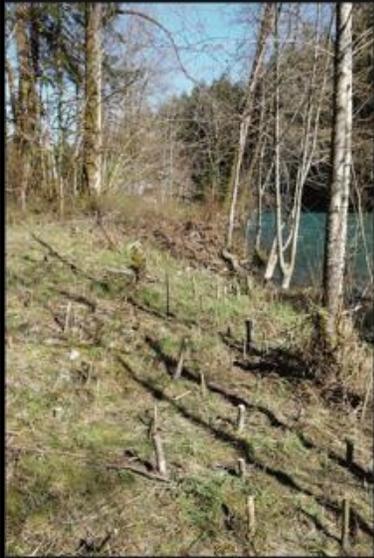
Appendix 6: Live-Staking Information Sign Used at Various CSSP Sites

**Cross section**  
Not to scale

Labels in diagram:  
- Live-staked tree  
- Root system  
- Soil structure  
- 2m x 3 foot (minimum spacing)  
- Live-staking  
- 1/2 to 1/3 inches in diameter  
- For protection  
- Geotextile fabric

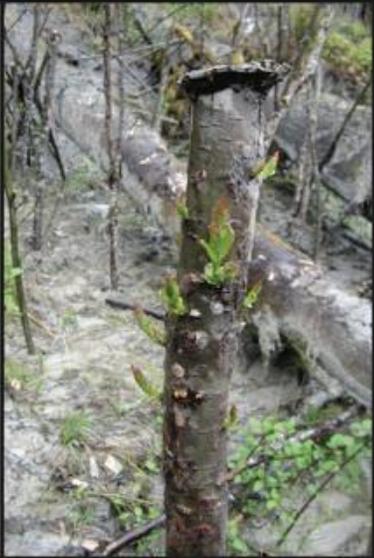
Note: Partial burial conditions of the living plant material is the responsibility of the user of this material.
